Charlie Eccleson – Sales & Support Engineer

## OVERCOMING THE CHALLENGES OF BRIDGE MOUNTED DETECTION A48 BRITON FERRY BRIDGE IN SOUTH WALES

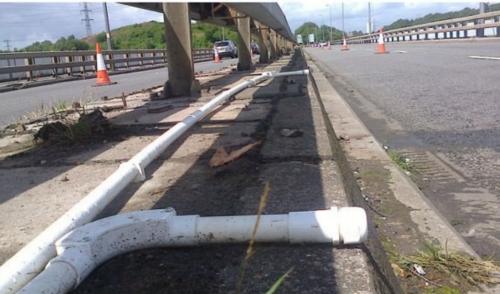
### Installation was completed August 2014

- ✓ Wired magnetometer detection was selected
- ✓ It was suggested that they could accurately detect vehicles if installed underground, adjacent to a traffic lane, rather than directly under the lane.
- $\checkmark$  15 years of maintenance-free design life was claimed

### Initial results were good for lane 1

• Most traffic was detected successfully

### **Results for Lane 2 were not so successful**

- The majority of drivers appeared to keep well to the left of the lane and kept outside of the range of the detection.
- Only a few vehicles were detected correctly

Although the installation was initially deemed successful, the detectors grew increasingly unreliable, culminating in total failure and requiring the South Wales Trunk Road Agency to seek replacement technology in 2023.
